## ALABAMA DEPARTMENT OF TRANSPORTATION

Subject: Annual Inspection Report

Walker County-Bevill Field Airport

## ANNUAL INSPECTION REPORT

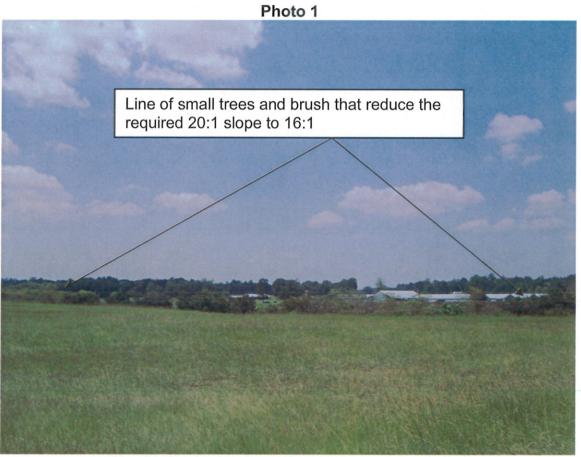
- Obstructions within the Approach/Departure Path violate the required 20:1 approach slope.
- → Obstructions within the FAA Runway Protection Zone violate the required 20:1 approach slope.
- → The obstructions reduce the approach slope to 16:1.

→ The obstructions are small trees growing in a line through the north side of the required obstruction-free area. See Appendix 2 for location of this tree line.

Runway 9 – North side of Approach/Departure Path

→ Remove this line of trees and brush. This line of growth has been noted as an obstruction in several previous reports. The growth has been trimmed in the past and has continued to grow and become a violation.

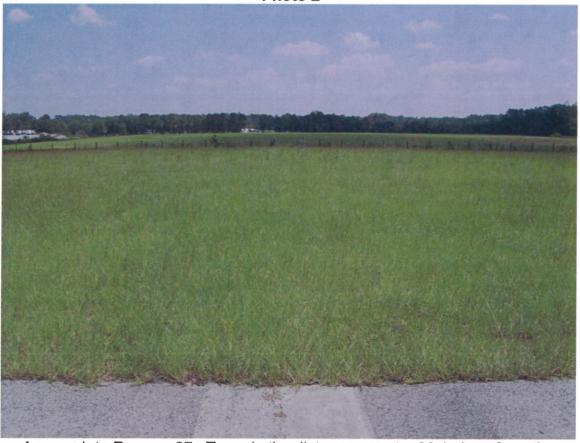
Approach to Runway 27. Trees in the distance are at a 36:1 slope from the displaced threshold.

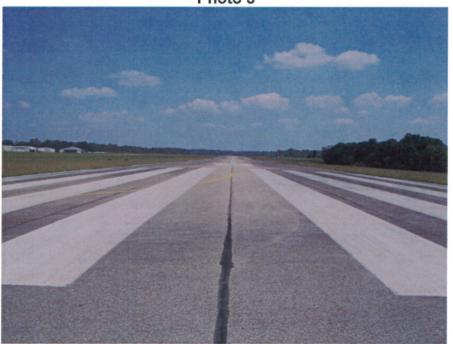
→ The runway markings are in FAIR condition.

Runway Identifier markings of Runway 9

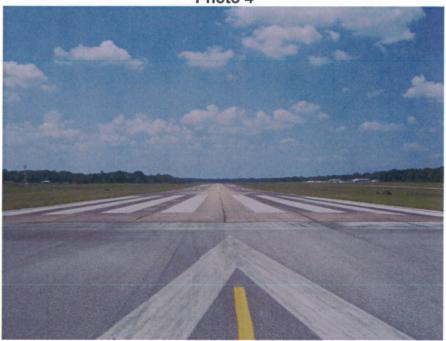
Photo 4

Runway Identifier markings of Runway 27

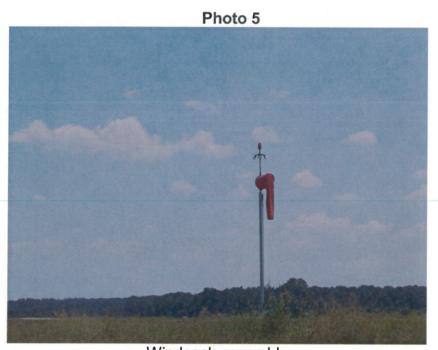
→ The wind direction indicator (windsock) was inspected and found to meet licensing requirements.

Windsock assembly

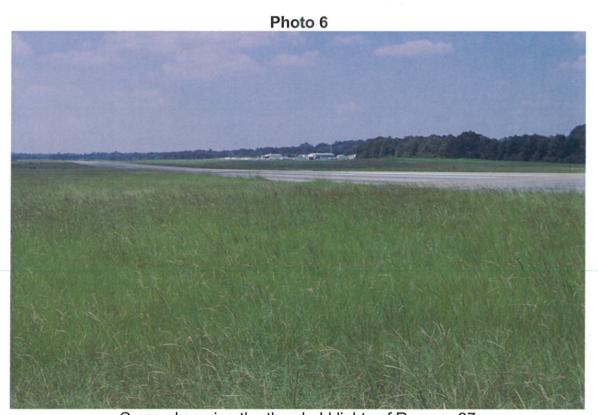
→ The runway lighting is obscured by tall grass.

Grass obscuring the threshold lights of Runway 27

> Keep grass mowed to height that does not obscure the runway lighting.

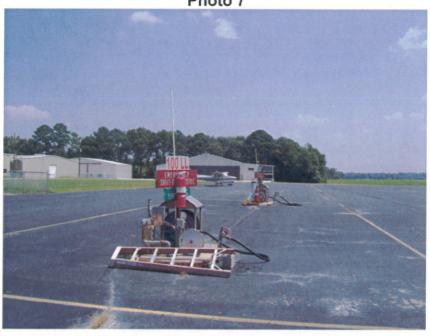
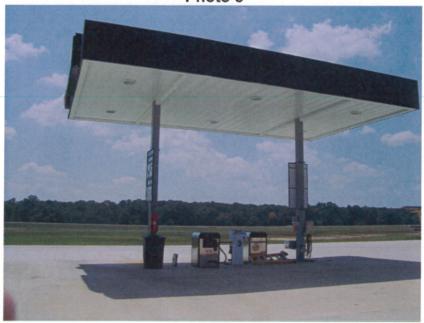
Photo 8

→ The fueling area meets the requirements established by the Alabama Department of Transportation. However, the State of Alabama Department of Agriculture and Industries may have additional requirements for fueling systems that were not considered during this inspection.

Fueling Areas

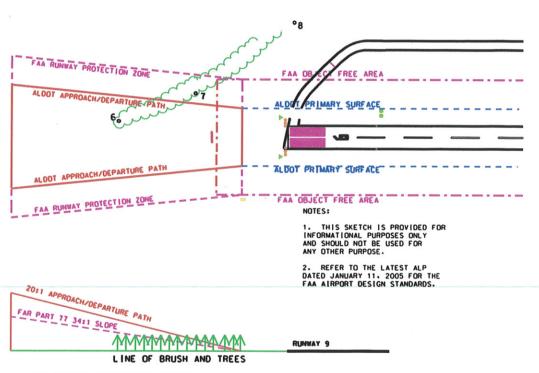
#### RUNWAY 9 PLAN AND PROFILE

VIOLATIONS OF THE 20:1 SLOPE

1. +12 TO +14 FOOT LINE OF BRUSH AND TREES
FROM THE RUNWAY END TO 735 FEET FROM THE RUNWAY END
SOO FEET FROM CENTERLINE TO 68 FEET FROM CENTERLINE
16:1 SLOPE
